***MASONRY STRUCTURES
AND THE
EDMONTON TORNADO***

M.A. Hatzinikolas
Executive Director
Prairie Masonry Research Institute
Edmonton, Alberta

J. Warwaruk
Professor of Civil Engineering
University of Alberta
Edmonton, T6G 2G7

December 1987

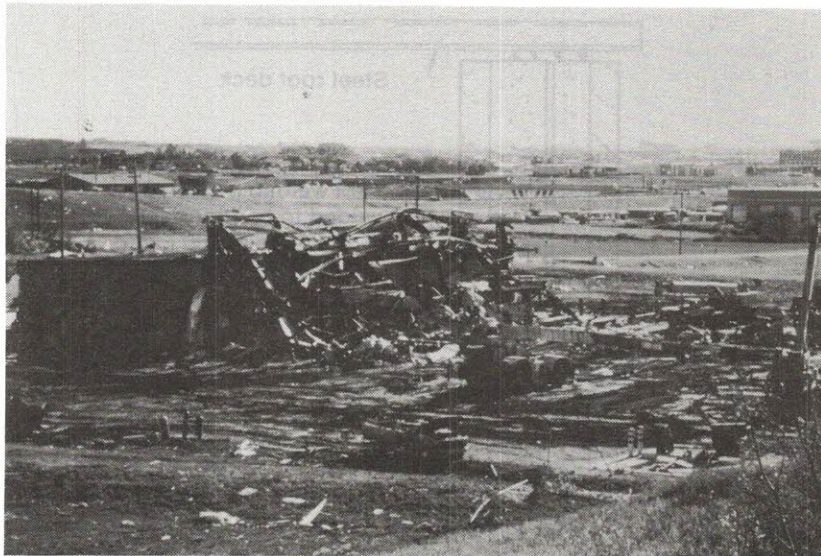
The destruction was complete and dramatic. Photo 2 shows the complete destruction of a steel structure, and Photo 3 shows a similar condition for a masonry building. Although all types of structures in the path of the tornado were destroyed the photos in this paper concentrate on the damage to masonry structures.

Photo 2. Complete destruction of a steel structure.

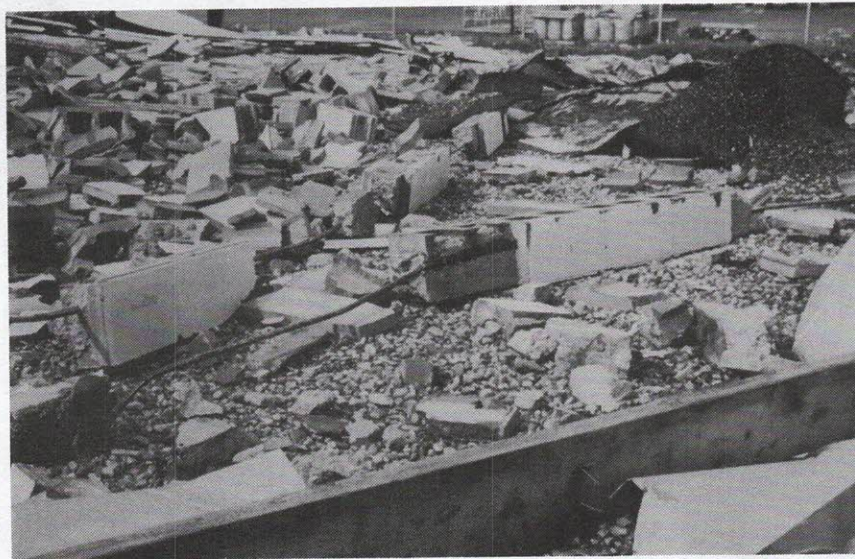
Photo 3. Totally destroyed masonry structure.

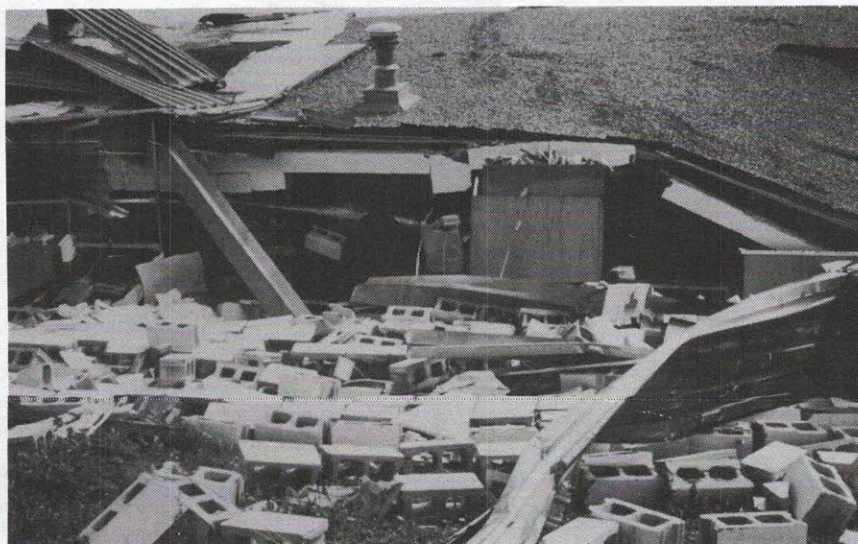
The structure shown in Photo 4 suffered extensive damage. Masonry walls collapsed outward indicating that external suction and/or internal pressure was the prime loading mechanism. It is surmised that the sequence of events leading to failure was as follows: uplift pressure on the roof and shear force at the connection of the steel joist to the walls caused the connection to fail and the free standing wall collapsed outwards. Note that the bond beam is attached to the roof and that no vertical reinforcement is evident in this photo.

Photo 4. Failure of masonry wall under suction.

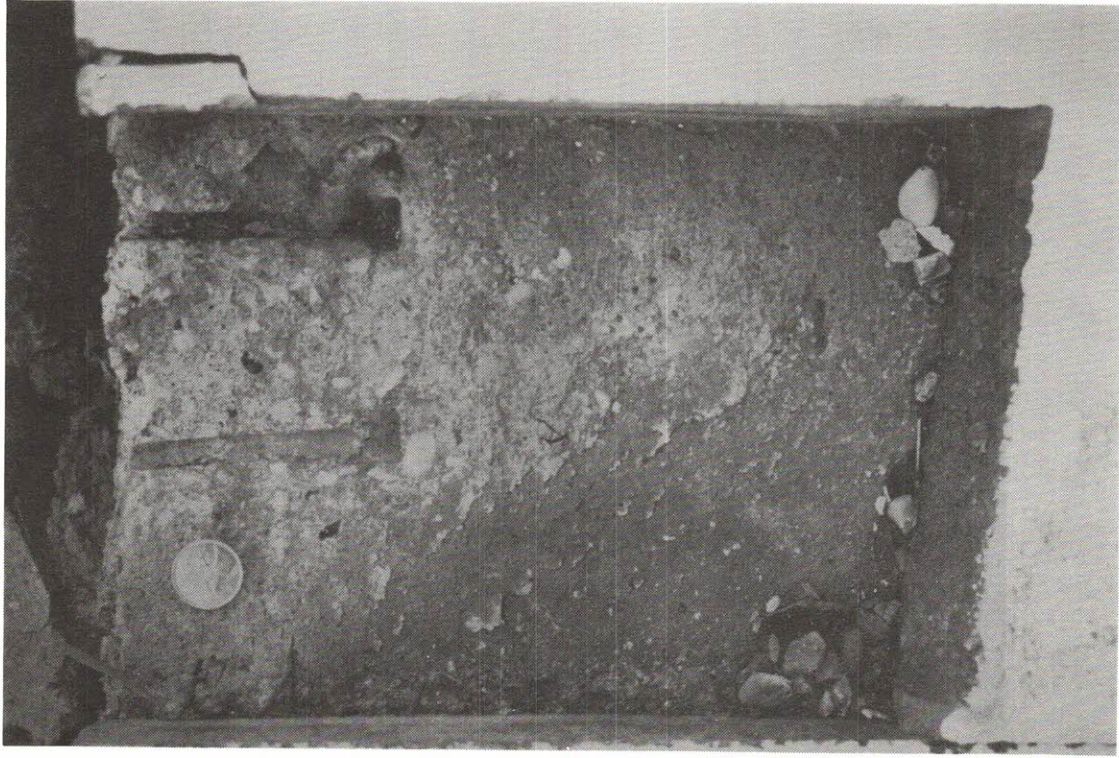
Portions of three different buildings collapsed because the bearing plates and connecting studs under the ends of the open-web steel joints were pulled out laterally from the bond beam. In all three cases, the studs under the bearing plates had been placed just inside the face shell of the block. Under lateral loads the face shell broke away and the studs were pulled out of the bond beams with little, if any, damage to the grouted core.

Bond beams typically contain one or two longitudinal bars intended primarily to provide for diaphragm action, and control of cracking. They are not designed to surround and contain the studs and in that way create a proper connection. Although the drawings of this building are not available it is doubtful that the placement of the bearing plates and studs received any special attention. Photos 5 and 6 illustrate the type of failure discussed.

Photo 6. Location of studs within the bond beam.

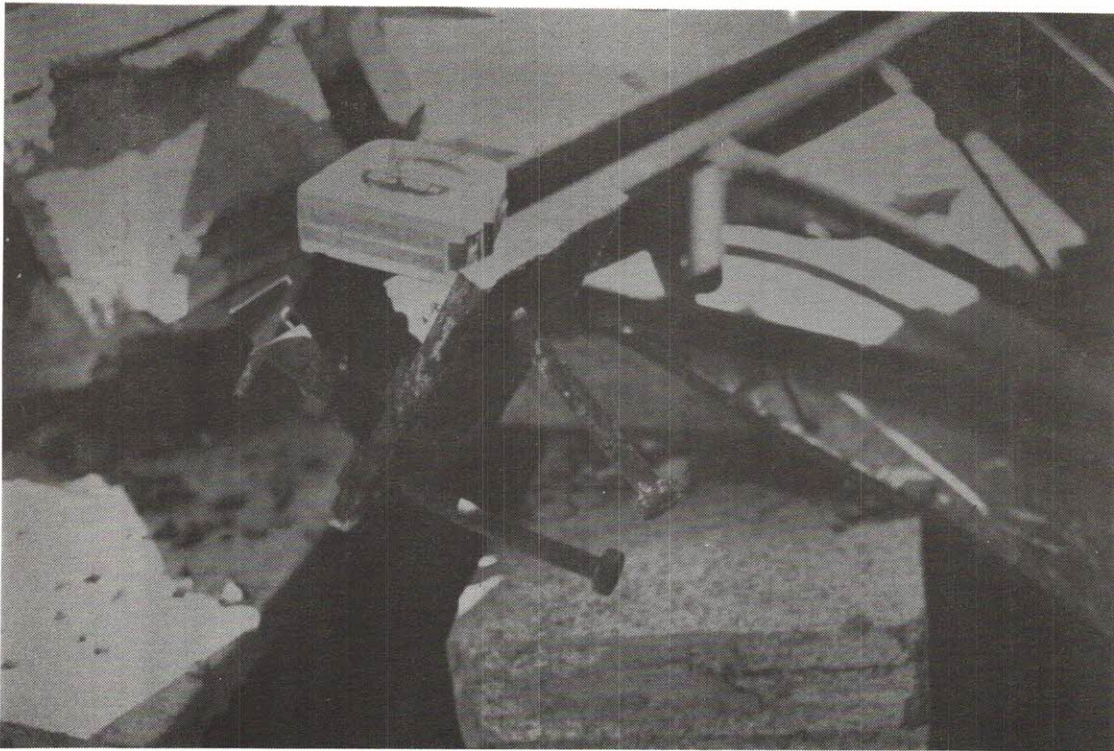
Photo 5. Open web steel joist and connection plate.

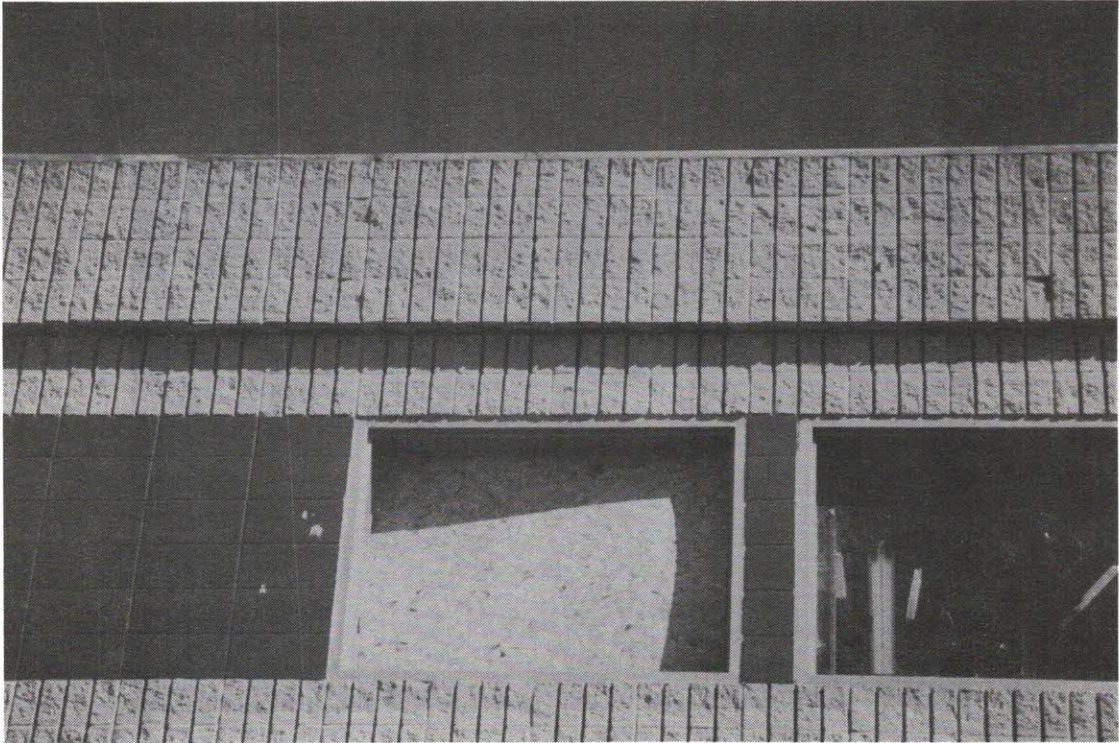
Inadequate anchorage of bond beams to walls caused the collapse of portions of four buildings and was evident in many others. Vertical bars in the wall are at times terminated at the joint below the bond beam, especially when a section through the walls shows the beams to be constructed from channel blocks. Photos 7 and 8 show separation of bond beams from the wall, and deflection of the assembly. From these photos the lack of reinforcement anchored into the bond beams, is very noticeable. In one case (Photo 8) a windward wall was shifted about 75 mm under a bond beam which was restrained by the roof diaphragm. This particular wall did not collapse, but it came uncomfortably close. Photo 9 shows the failure of the corner of a structure subjected to a mechanism schematically illustrated in Figure 5. Photo 10 shows uplift of a roof subjected to a mode shown in Figure 3.

Photo 7. Separation of bond beams from the rest of the wall.

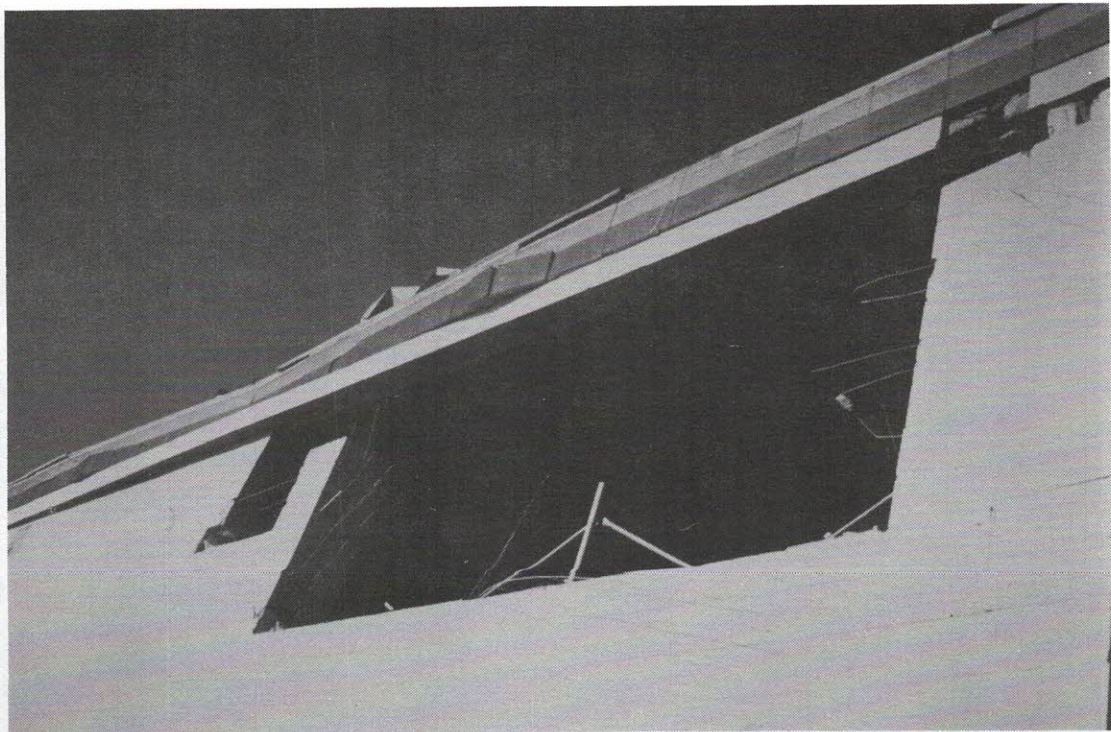
Photo 8. Collapse of wall caused by improper anchorage to the bond beam.

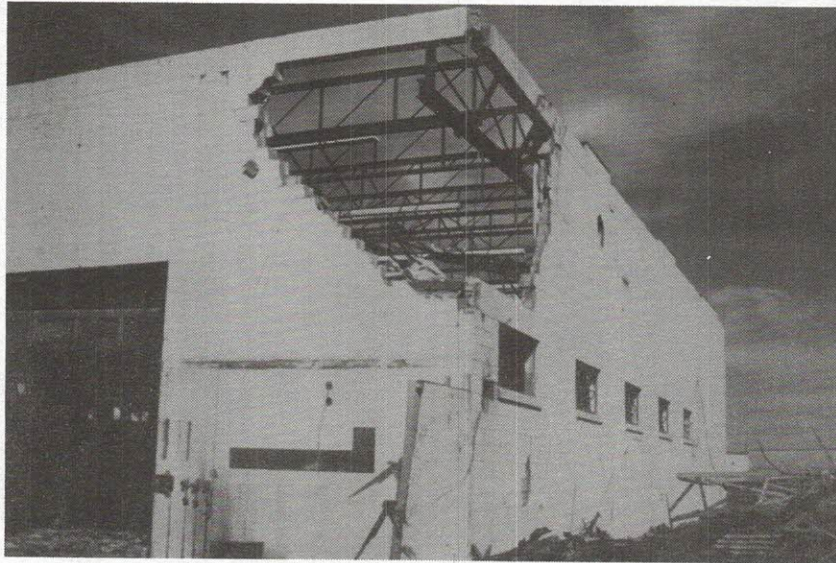
Photo 9. Failure of concrete walls under the action of wind loads.

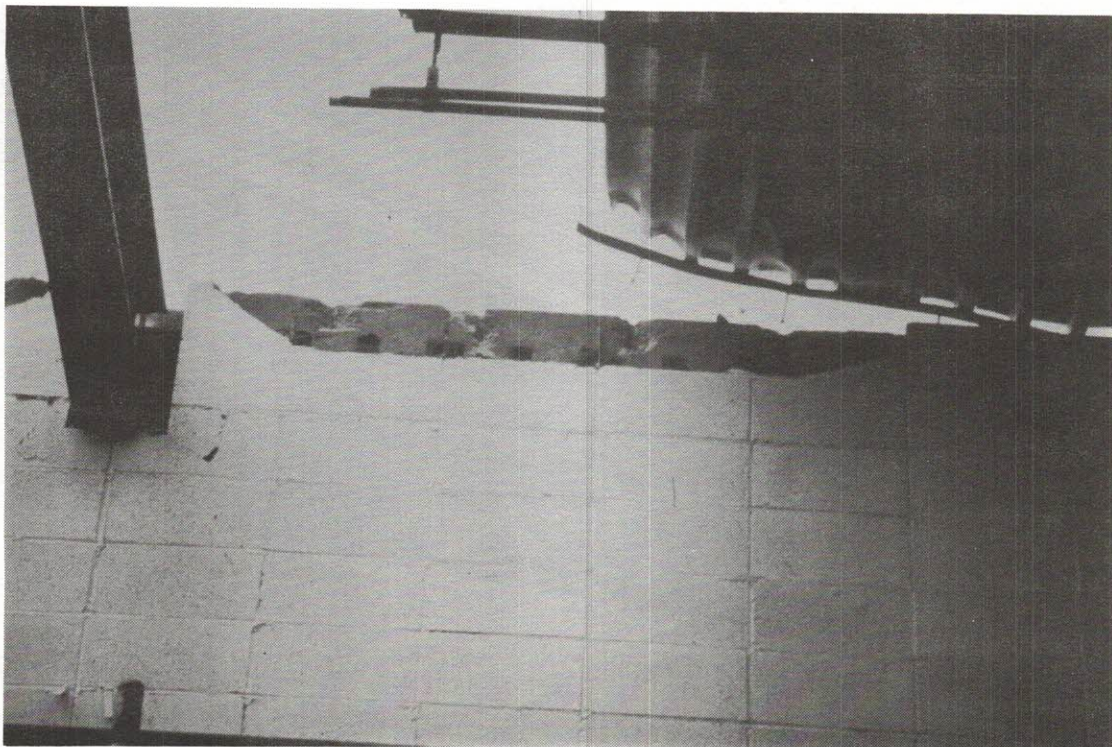
Photo 10. Failure of roof due to uplift.

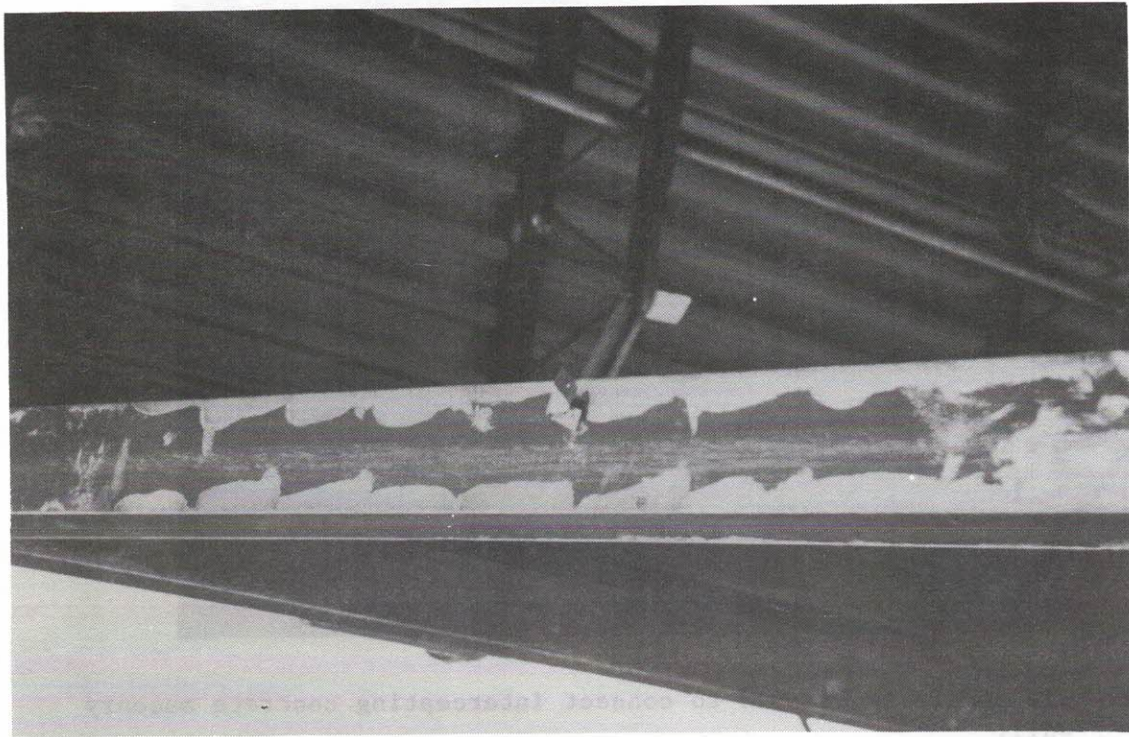
Partition walls and intersecting walls that failed are shown in Photos 11 and 12. Infill panels failed because of improper connection to the steel column. Photo 13 shows an intersecting internal wall connected by means of a 28 gauge corrugated strip mechanically fastened in the mortar joint by means of a 12 mm concrete nail, the size of which is shown in Photo 14.

Photo 11. Infill panel connected to steel column by means of 28 gauge corrugated strip.

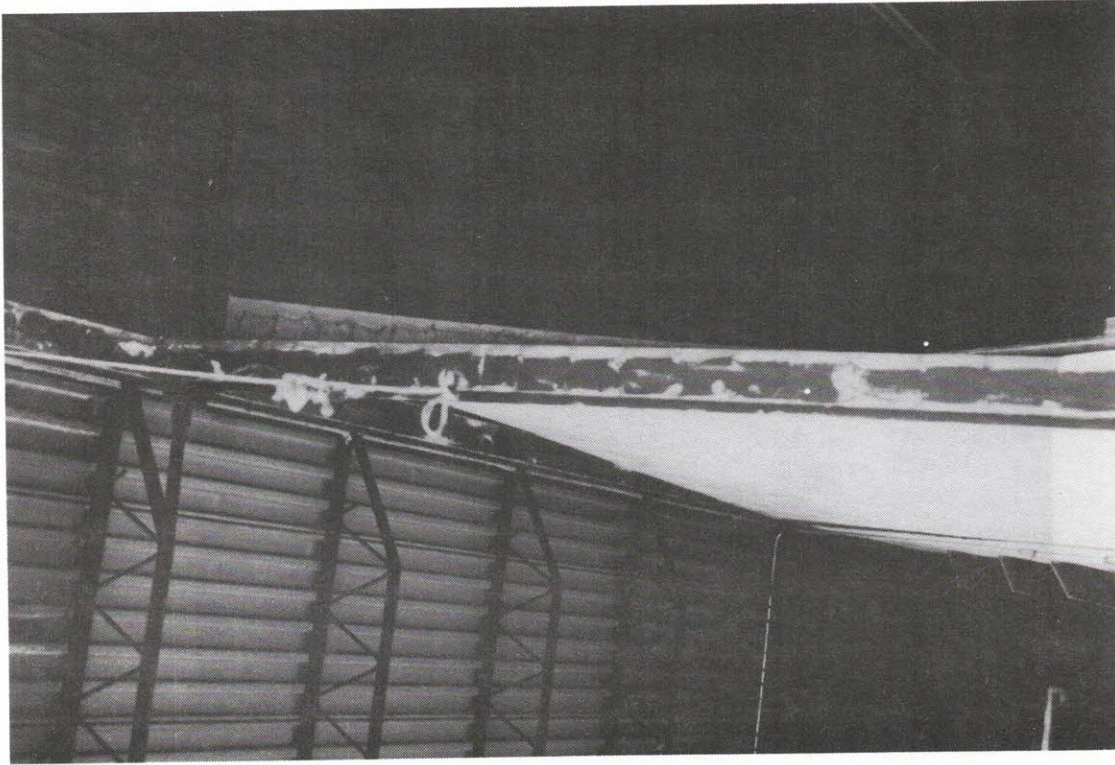
Photo 12. Concrete block wall shifted from the supporting steel column because of improper anchoring.

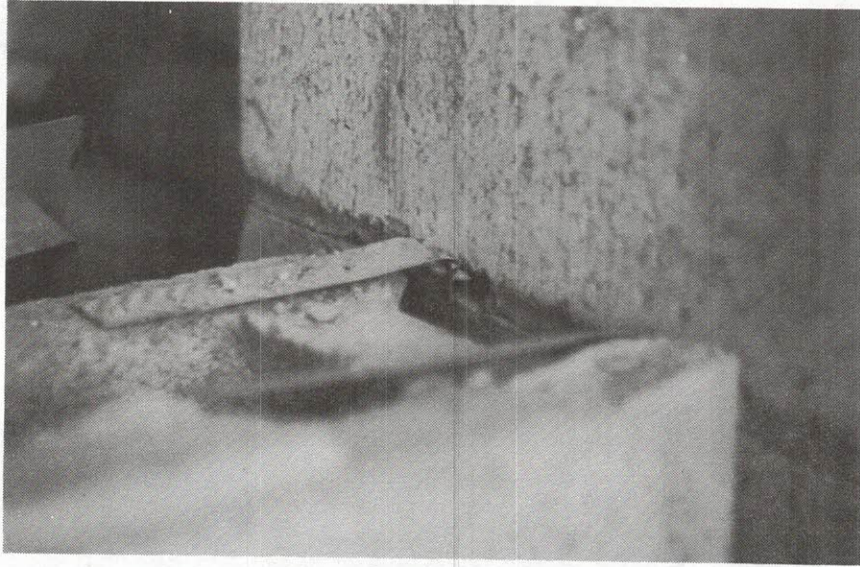
The walls discussed above were connected to the front of the structure by means of a piece of plywood on which corrugated strip ties were attached and then embedded into the mortar joint. The plywood in turn was nailed by standard 40 mm nails to a wood panel. This connection detail probably failed prior to the failure of the roof-wall connection.

Photo 13. Connection detail of failed wall.

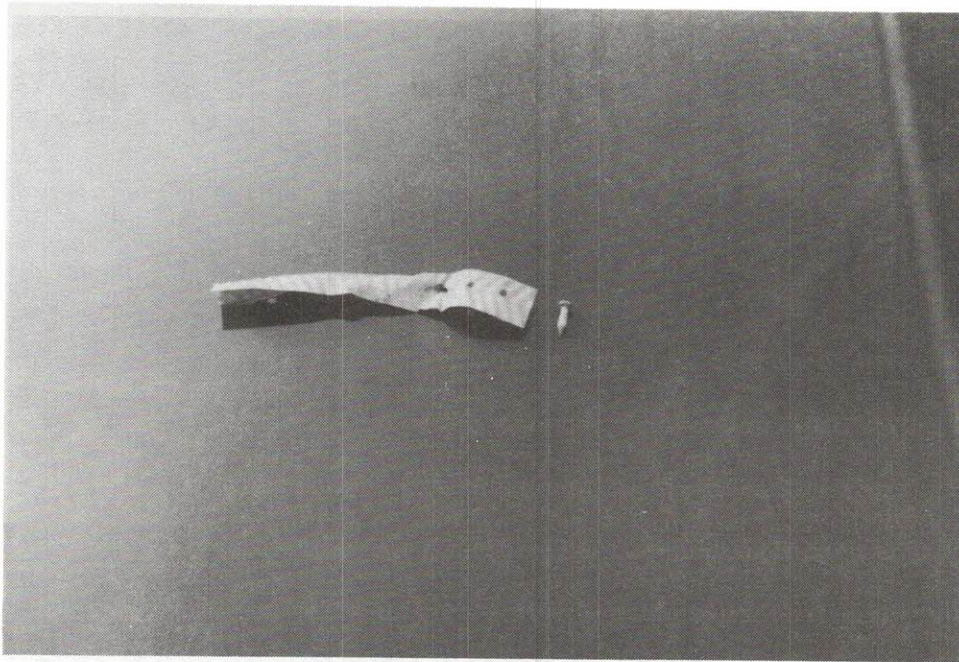
At the rear of the same structure an exterior wall failed by complete separation at the connection to the intersecting masonry wall. The interior wall was connected by means of 28 gauge corrugated strip ties embedded in the mortar joint and fastened by means of a 12 mm concrete nail driven into the mortar joint of the rear wall. The connector was similar to that shown in Photo 14. Clearly, this type of connection is grossly inadequate.

Photo 14. Tie and fastener used to connect intercepting concrete masonry wall.
