***MASONRY STRUCTURES
AND THE
EDMONTON TORNADO***

M.A. Hatzinikolas
Executive Director
Prairie Masonry Research Institute
Edmonton, Alberta

J. Warwaruk
Professor of Civil Engineering
University of Alberta
Edmonton, T6G 2G7

December 1987

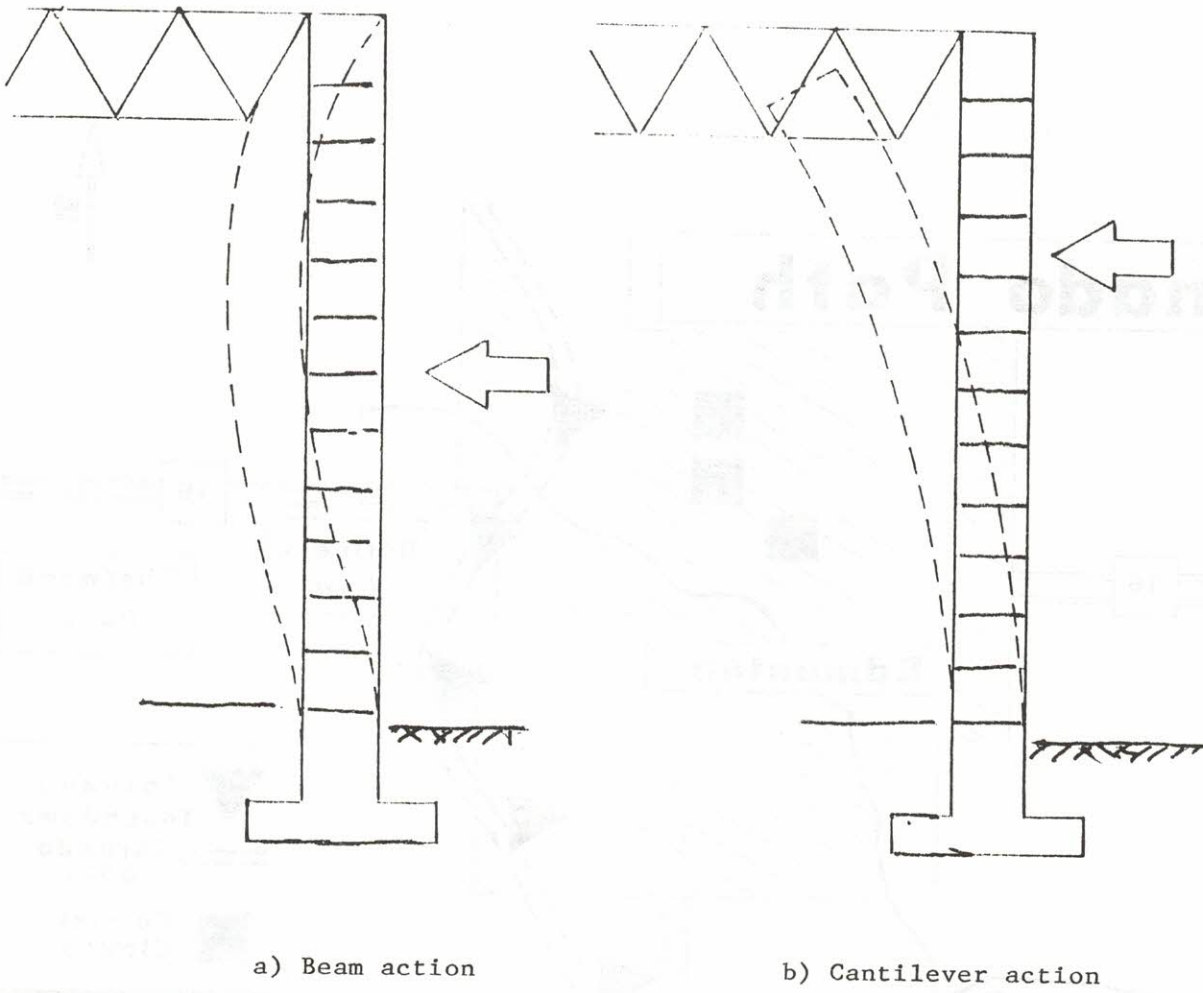
loading conditions is affected by the capabilities of the wall, and by its interaction with and performance of the other structural elements. If, for example, the roof connection fails and it separates from the wall (Fig. 3), the wall acts as a cantilever and collapses inwards. The behaviour of walls such as shown in Figure 2 will depend on the layout of the structure as it relates to roof diaphragm action and unsupported height of the wall. Structures with small (short) walls and stiff and heavy roofs will deform as shown in Figure 2a. However, structures with tall walls and long roofs will tend to deform as shown in Figure 2b.

Figure 2. Response of masonry walls to external pressure.

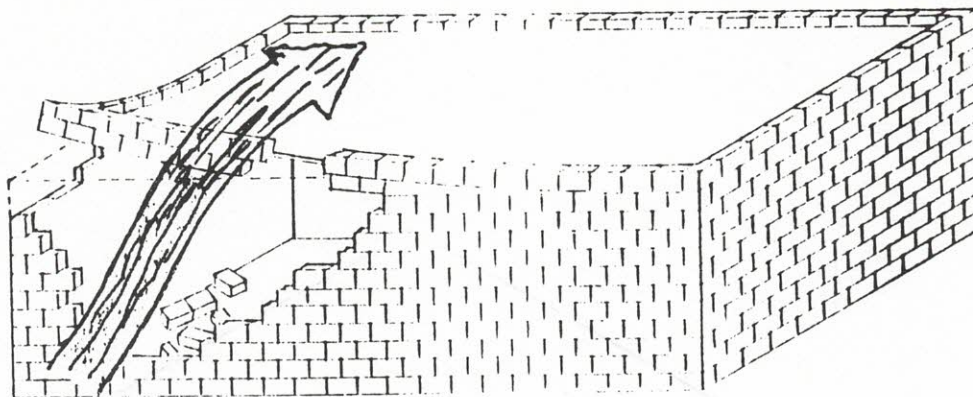
Figure 3. Uplift of roof due to suction.

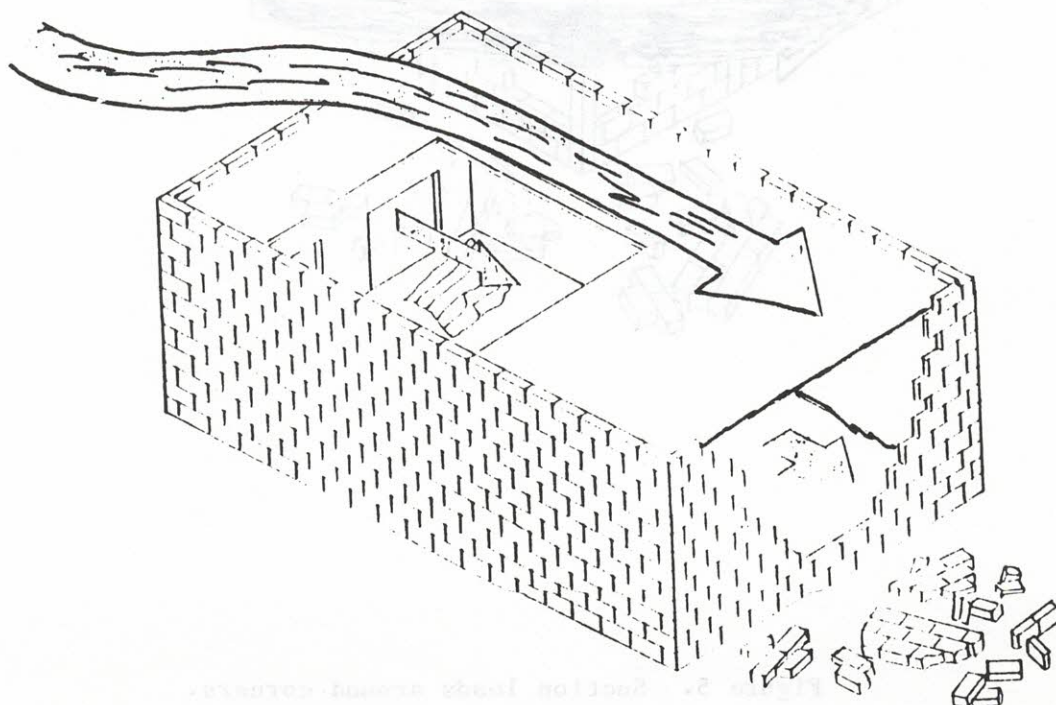
Figure 4. Internal pressure on walls after door collapsed.

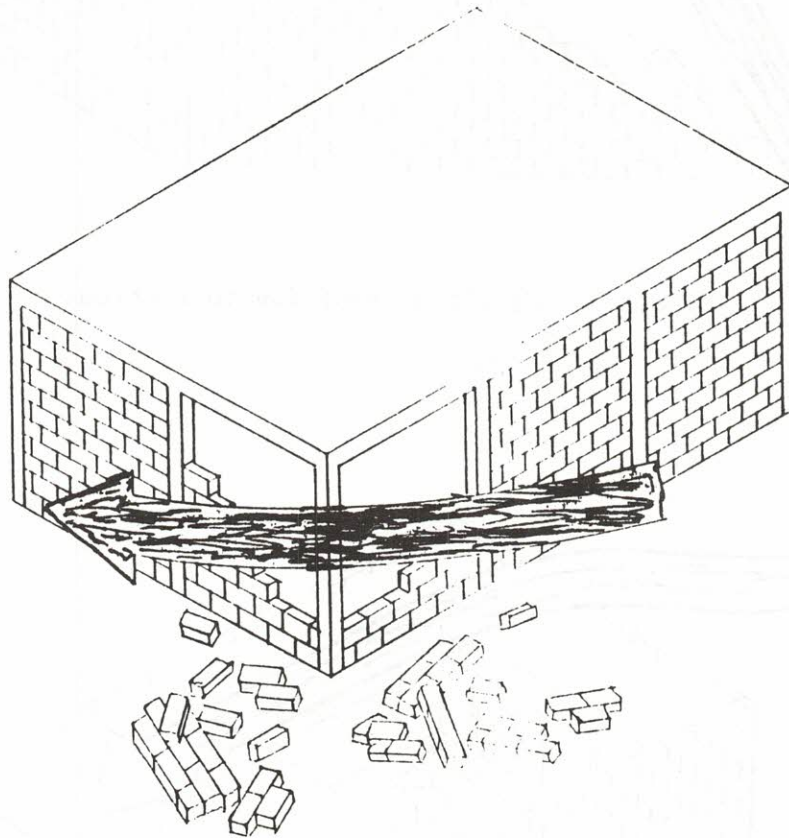
Inadequate anchorage of bond beams to walls caused the collapse of portions of four buildings and was evident in many others. Vertical bars in the wall are at times terminated at the joint below the bond beam, especially when a section through the walls shows the beams to be constructed from channel blocks. Photos 7 and 8 show separation of bond beams from the wall, and deflection of the assembly. From these photos the lack of reinforcement anchored into the bond beams, is very noticeable. In one case (Photo 8) a windward wall was shifted about 75 mm under a bond beam which was restrained by the roof diaphragm. This particular wall did not collapse, but it came uncomfortably close. Photo 9 shows the failure of the corner of a structure subjected to a mechanism schematically illustrated in Figure 5. Photo 10 shows uplift of a roof subjected to a mode shown in Figure 3.

Figure 5. Suction loads around corners.

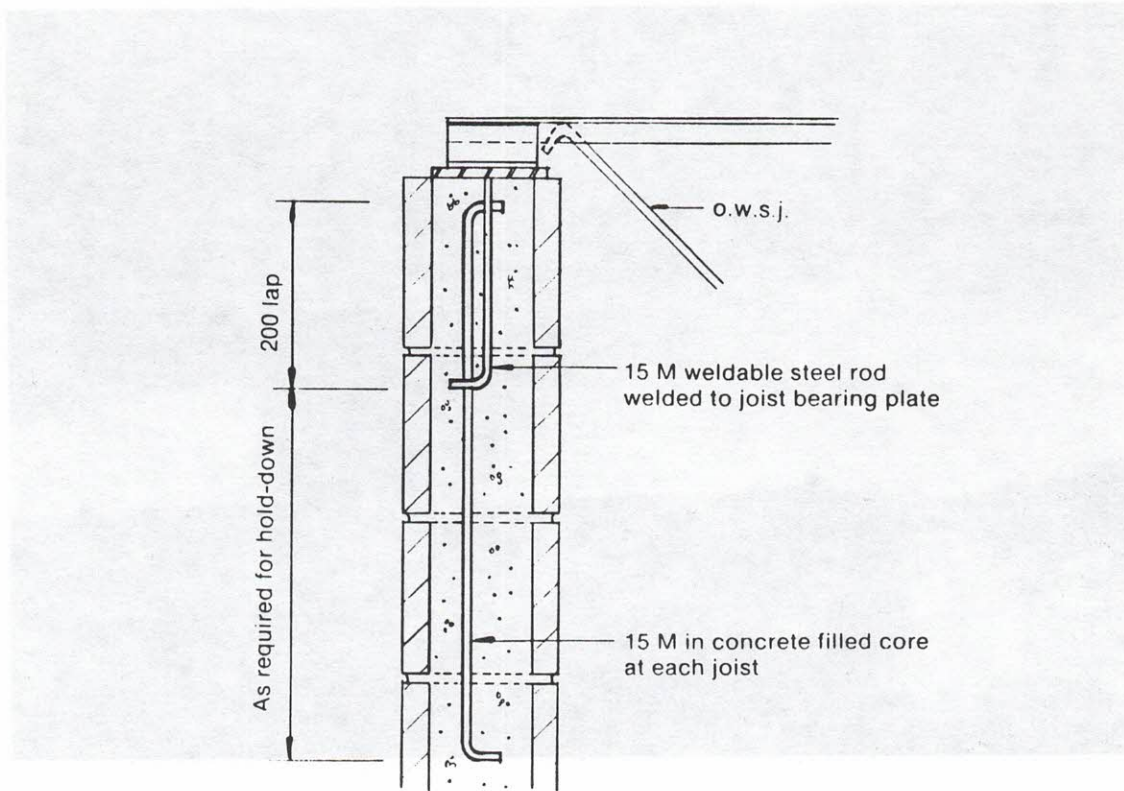
Figure 6. Properly anchored joist.

Placing a 15 mm reinforcing rod in walls every 3000 to 3500 mm must be considered as a minimum for ductility requirements. Partially reinforced masonry must replace plain masonry in the construction of structures. This type of construction is now permitted by CSA Standard S304-M84 "Masonry Design for Structures". The type of failure described under roof to wall connection have been noted by other investigators (1,2,3). The minimum requirements for uplift protection should be as shown in Figures 6 and 7 which have been taken from CSA Standard A370-M84 "Connectors for Masonry".

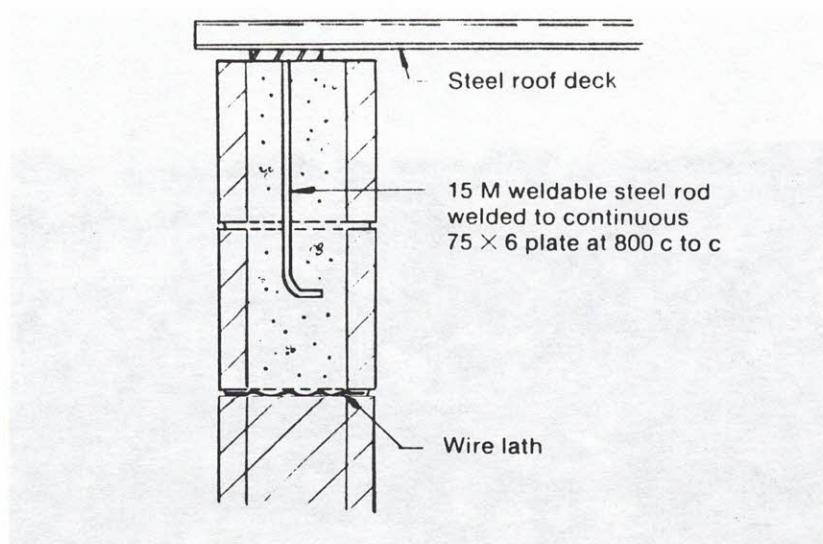
Figure 7. Properly anchored steel roof deck.
