THE EFFECT OF JOINT REINFORCEMENT ON VERTICAL LOAD CARRYING CAPACITY OF HOLLOW CONCRETE BLOCK MASONRY

M. Hatzinikolas¹, J. Longworth², J. Warwaruk³

**CANADIAN
MASONRY
RESEARCH
INSTITUTE**

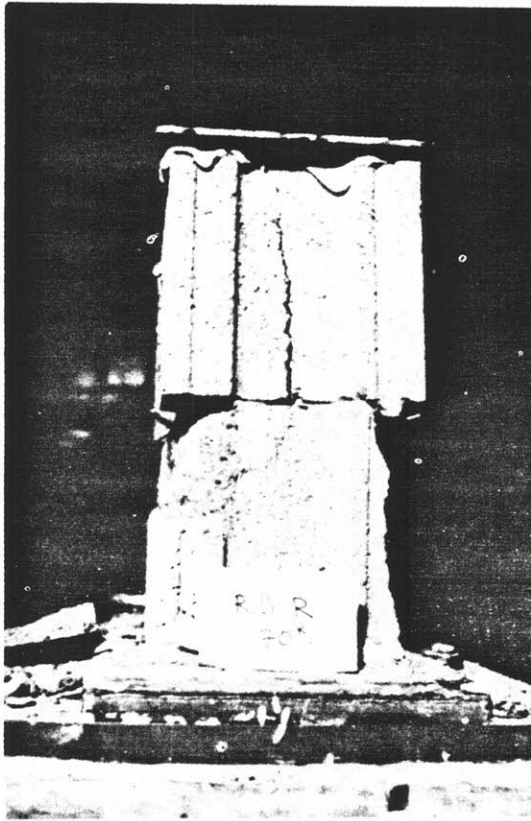
PLATE 2 - Typical Failures of Prisms With No. 9
Gauge Wire Joint Reinforcement

Failures were caused by splitting of the block at the cross webs for plain specimens and splitting at the flanges for the reinforced ones. These types of failures are illustrated in Plate 2.
